# Manhole Inspection Summary

Manhole # S41AA\_018MH

Insp Date: **8/6/08 11:20 AM**

**Location** Address: **725 mello ct**

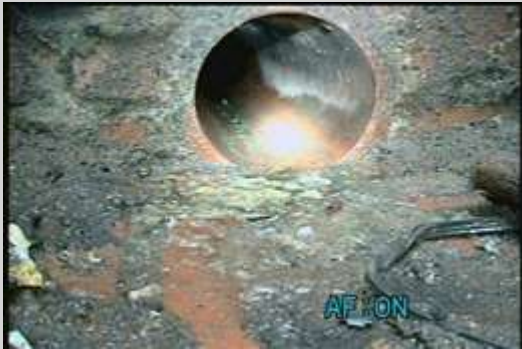
12 O'Clock Outflow

8 in. Circular Gravity Sewer  
Pipe Out @ 12 O'Clock

Infiltration: **None** Pipe Seal Cond: **Unknown**
